Bulletin Number: VF-015
Effective: October 1, 1991

EXTERNAL LEAKAGE: CLAMP SUPPORT MODIFICATION

Affected Models: All VacuFlush® and Traveler® toilets.

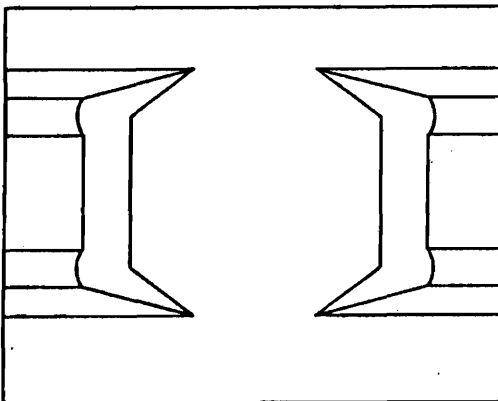
Old Style

Symptom: Occasionally an external leak of bowl contents occurs in the rear of the toilet base area. Visible inspection of all components reveals no cracking or distortion. Leak occurs while customer is sitting on unit.

Cause: A study of the bowl-to-base seal was conducted to simulate loading in use. It was discovered that excessive front loading (in excess of 250 pounds) on the bowl caused the clamp supports holding the toilet base and bowl together to shift out of position.
