WATER LEAKAGE ON BRISK AIR TYPE HEAT PUMPS AND AIR CONDITIONERS

DOMETIC & DUO-THERM AIR CONDITIONING BULLETIN A24/8B March 1998

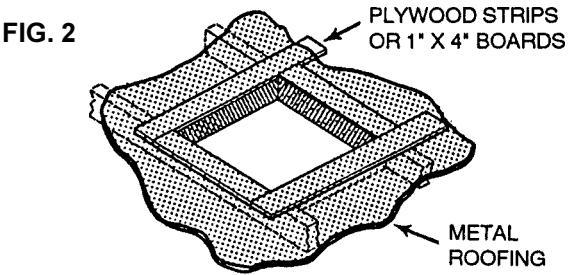
For a roof with standard rafter-type construction, a drainage problem can usually be corrected by placing additional framing between the metal roofing and the rafters, as shown in Figure 2, thus raising the unit and creating a slope away from the unit. Roofs constructed from laminated material, etc... consult coach manufacturer for their recommendations.

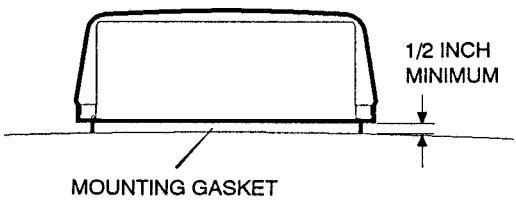
FIG. 3

When attaching the unit to the roof, tighten the mounting bolts only enough to compress the mount-ing gasket to **1/2 inch** (40 inch pounds of torque).

DO NOT OVER-TIGHTEN the mounting bolts as you may damage the unit base.

Once the unit has been installed, the mounting gasket will retain its installed thickness. If the unit is removed for inspection or service, avoid a future problem by installing a new 14" x 14" gasket (Part No. 3100247.000) when you reinstall the unit.

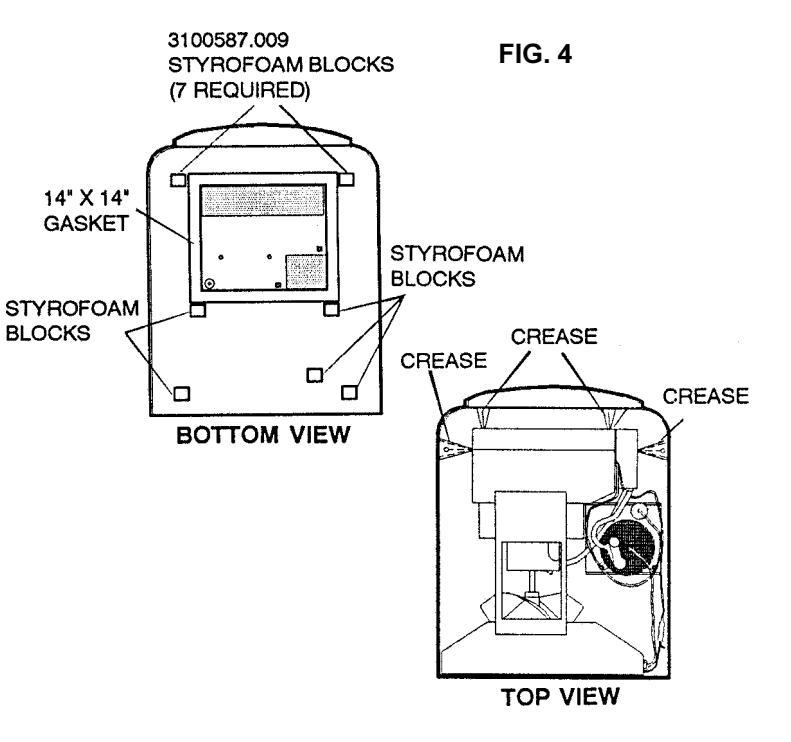
- Seven styrofoam blocks have been placed on the underside of the base pan. The styrofoam blocks provide an even support for the base pan which prevents it from bending and warping during installation. Over-tightening of the mounting bolts described in **Corrections Step 1.2**, can cause the styrofoam blocks to act as a wedge and force the edges of the base upward. (See Figure 4).

- 2) The rolling and bending of the base pan caused by over tightening of the mounting bolts will let the plastic drain pan pull away from the sealant. Water can flow through the gap between the plastic drain pan and sealant. The water becomes trapped under the plastic drain pan and can enter the interior of the RV through screw holes, etc.. It may be possible to remove the unit and straighten the base pan; however, if the plastic drain pan has pulled away from the sealant it may not reseal. In those cases the entire base pan will require replacement.

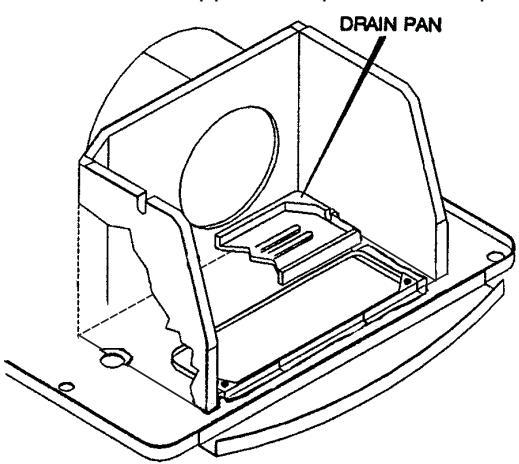
Inspect the drain pan for broken lip, cracks, and plugged outlets. Be sure the drain pan is sealed to the base and look for water trapped under the plastic drain pan. Pressing on the center and edges of the plastic drain pan will move air bubbles that can be seen under it. Breaks, cracks or loss of seal between the plastic drain pan and the base will require replacement of the entire base pan on the unit. Cleaning of the drain outlets will correct problems with water that is trapped on top of the drain pan.
