T.I.P. Troubleshooting Information on Power Gear

SLIDEOUT GEAR SHAFT REPLACEMENT FOR 520258S AND 520259S SERVICE KITS

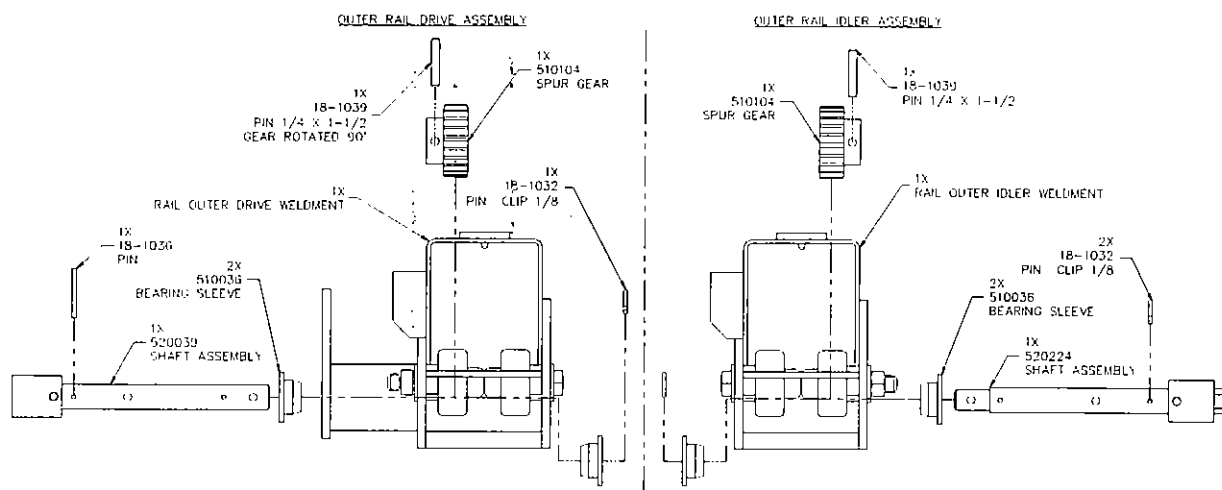
520258S KIT SHAFT DRIVE

520259S KIT SHAFT IDLER

QTY. P/N DESC.

1	520104	- SPUR GEAR
1	18-1032	- PIN CLIP .125
1	5200039	- SHAFT ASSY.
1	18-1039	- PIN 1/4 X 1-1/2
2	510036	- BEARING SLEEVE
1	18-1036	- PIN

1	520104	- SPUR GEAR
2	18-1032	- PIN CLIP .125
1	520224	- SHAFT ASSY.
1	18-1039	- PIN 1/4 X 1-1/2
2	510036	- BEARING SLEEVE
1	18-1036	- PIN

1. Disconnect battery.
 2. Remove all items necessary to access outer rail gear assembly.
 3. If motor is mounted to rail, remove the motor mounting bolts and remove the gearmotor.

4. Remove the drive shaft bolt and slide the drive shaft away from the outer rail assembly.
 5. Remove the cotter hair pin from the gear shaft.
 6. Slide the gear shaft to disengage the gear from the rack and rotate the gear shaft until the spur gear shear pin is visible.

7. Remove the shear pin.
 8. Pull the gear shaft out of the outer rail assembly, removing the spur gear from the shaft.
 9. Remove the bushings from the shaft plate. Insert the new bushings into the shaft plate. Slide the new gear shaft back into the outer rail assembly through the first bearing sleeve.

10. Slide the new spur gear onto the gear shaft.
- Align the spur gear hole to the hole in the shaft and slide the gear shaft through the second bearing sleeve. **Note: orientation of hub on gear when fully assembled gear teeth on gear and rack must line up If not, gear must be removed from shaft and rotated 180°.**

11. Verify the hole alignment and insert a new shear pin, making sure that the shear pin is inserted completely.
 12. Disengage the gear from the rack and rotate the gear shaft until the gear shaft hole and drive shaft hole line up.

13. Engage the gear and rack by sliding the gear shaft back through the second bearing sleeve.
 14. Replace the cotter hairpin in the gear shaft.
 15. Slide the driveshaft back into position over the gear shaft and replace the driveshaft bolt with the correct number of washers and lock nut. **Refer to TIP Sheet #73 "Torque specification for Slideout Drive Shaft Bolts"** for proper assembly of the driveshaft bolt, washer and nut.

16. Reinstall the gearmotor (if applicable) and bolt and nut into place.
 17. Check to verify both inner rails are aligned by measuring the distance from the unit wall to the wall of the slideout room (both sides of the room). If the (2) measurements vary more the 1/8", refer to **"TIP Sheet #70 "Inner rail realignment"** to realign the rails.

18. Replace all items that were removed to access the outer rail assembly.
- Reconnect the battery and test the system operation.
